2007 Air Photo Classification Emergent Vegetation Coverage

STORMWATER TREATMENT AREA 1 EAST

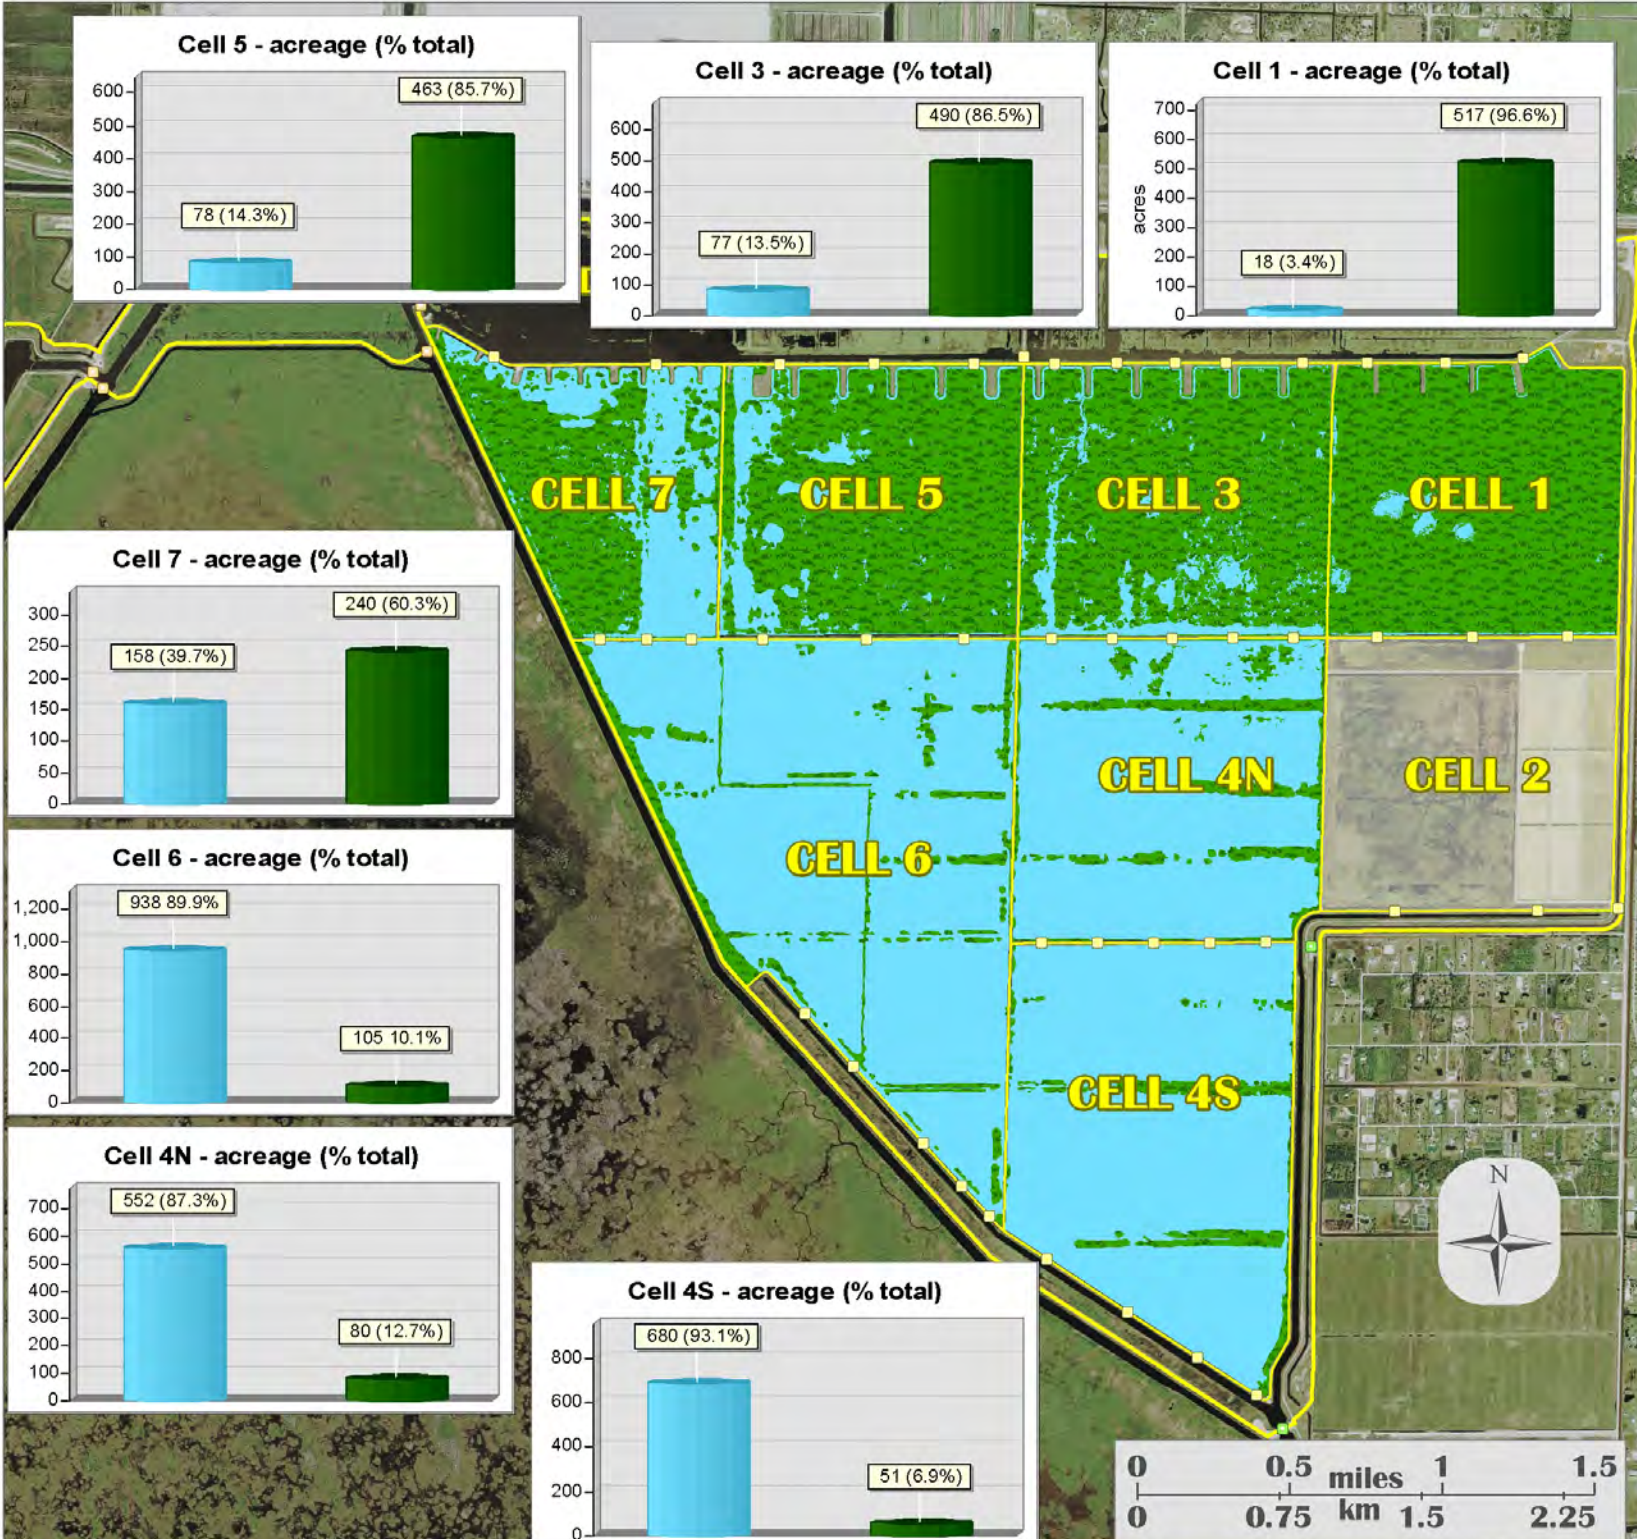
2009 Air Photo Classification Emergent Vegetation Coverage

classification imagery - color infrared 1 foot resolution captured in April 2009
(RASLIB.STA_2009_CIR_1FT_JPG)

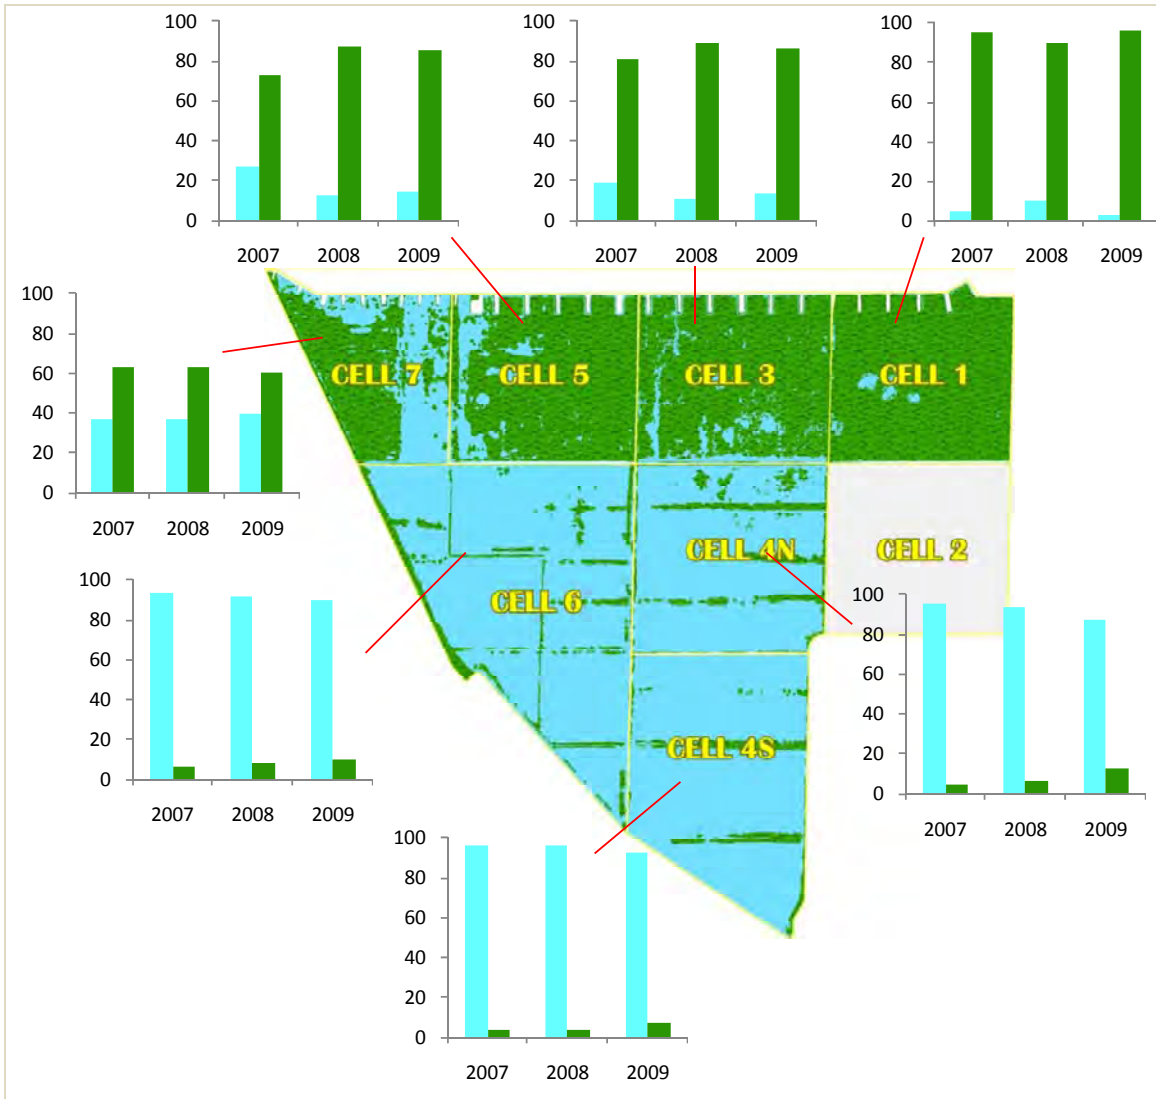
Figure 1. Changes in percent vegetation coverage in Stormwater Treatment Area 1 East (STA-1E) (2007–2009) based on aerial images. Blue bars and map area represent submerged aquatic vegetation (SAV)-open water and green bars and map area represent emergent aquatic vegetation (EAV). The map shows vegetation coverage from the 2009 aerial images. Compiled by the SFWMD.

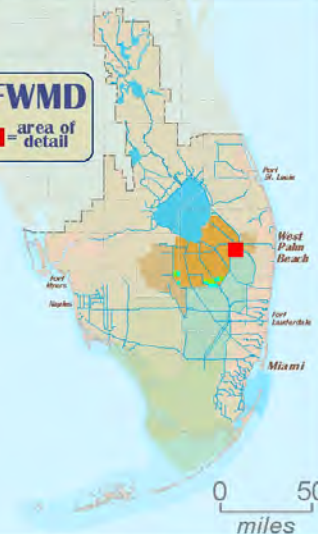
STA-1W

2007 Air Photo Classification Emergent Vegetation Coverage

emergent vegetation
-

open water/SAV

classification imagery - color infrared 1 foot resolution captured in April 2007

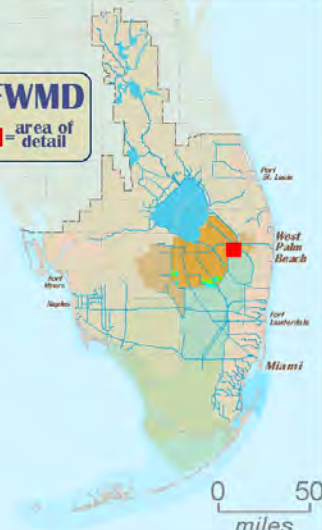
STA-1W

2008 Air Photo Classification Emergent Vegetation Coverage

- emergent vegetation
- open water/SAV

classification imagery - color infrared 1 foot resolution captured in April 2008

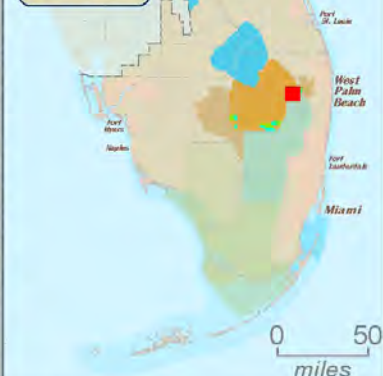
STA-1W

2010 Air Photo Classification Emergent Vegetation Coverage

emergent
 vegetation

open
 water/SAV

classification imagery -
 color infrared 1 foot
 resolution captured
 in May 2010
 (\\gisdata1\raster\image_aerial\sta_
 STA_2010_CIR_1FT_IP2.lyr)

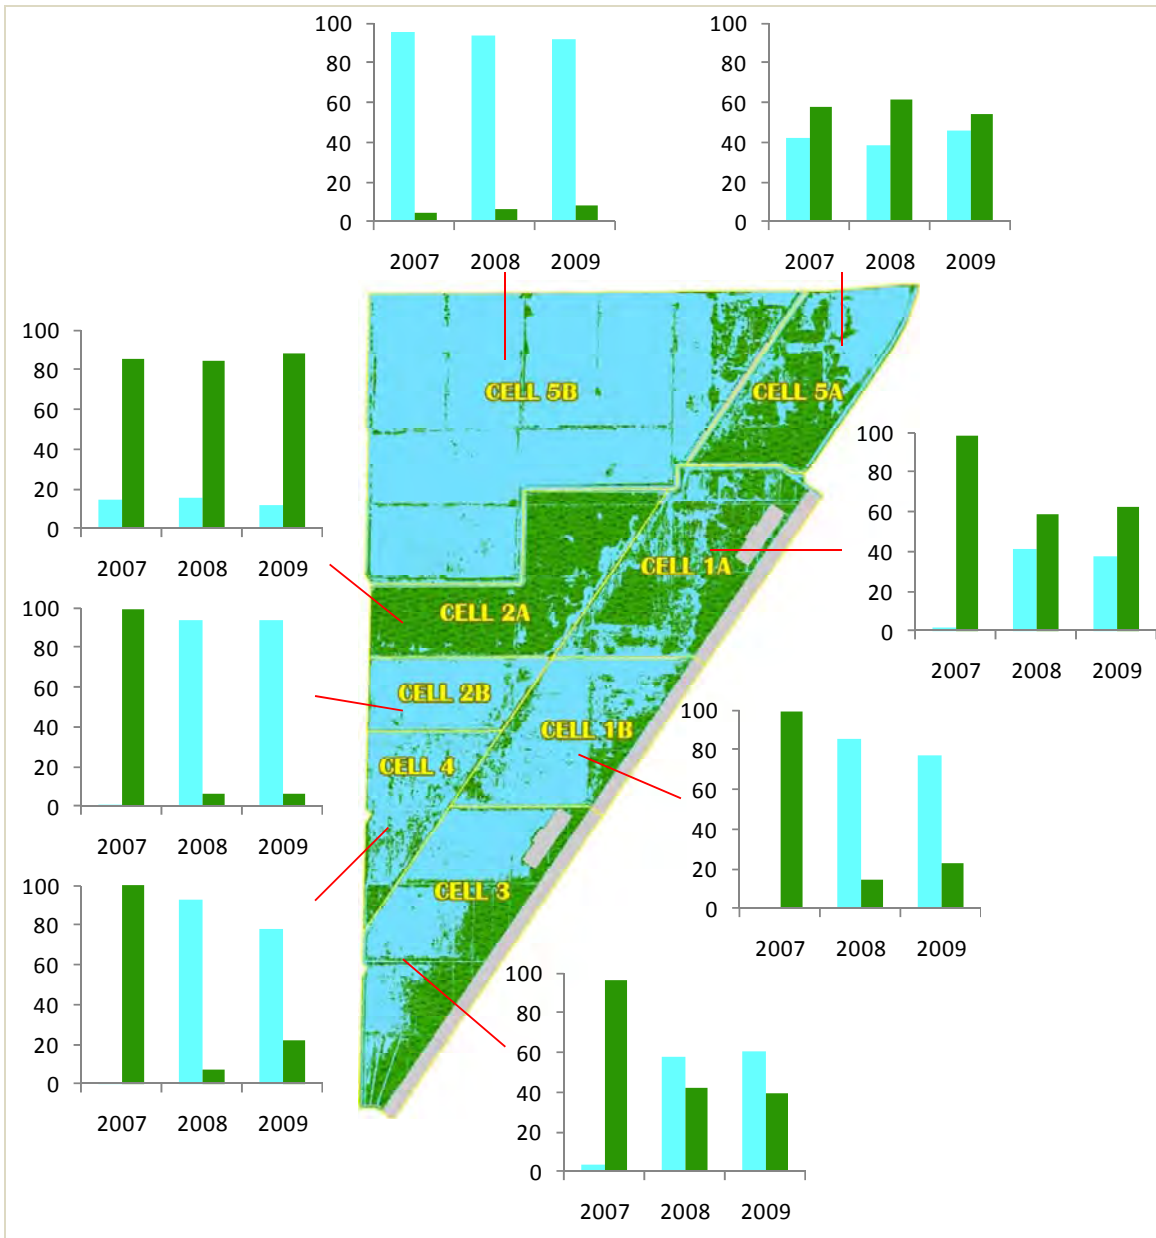
Figure 2. Changes in percent vegetation coverage in Stormwater Treatment Area 1 West (STA-1W) (2007–2009) based on aerial images. Blue bars and map area represent SAV-open water and green bars and map area represent EAV. The map shows vegetation coverage from the 2009 aerial images. Compiled by the SFWMD.

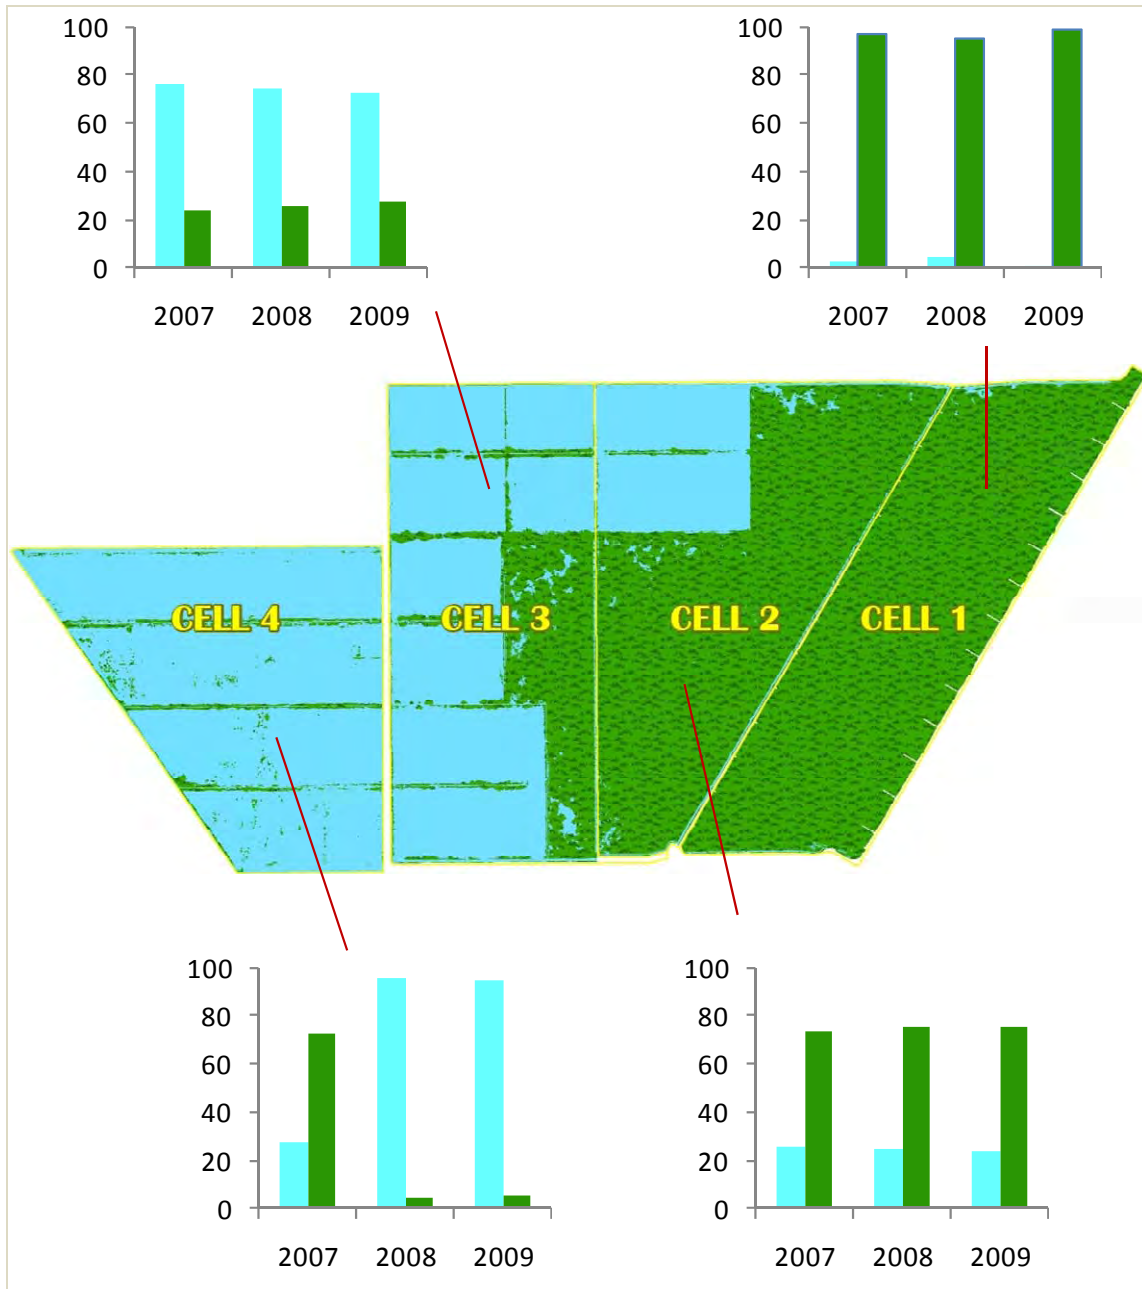
Figure 3. Changes in percent vegetation coverage in Stormwater Treatment Area 2 (STA-2) (2007–2009) based on aerial images. Blue bars and map area represent SAV-open water and green bars and map area represent EAV. The map shows vegetation coverage from the 2009 aerial images. Compiled by the SFWMD.

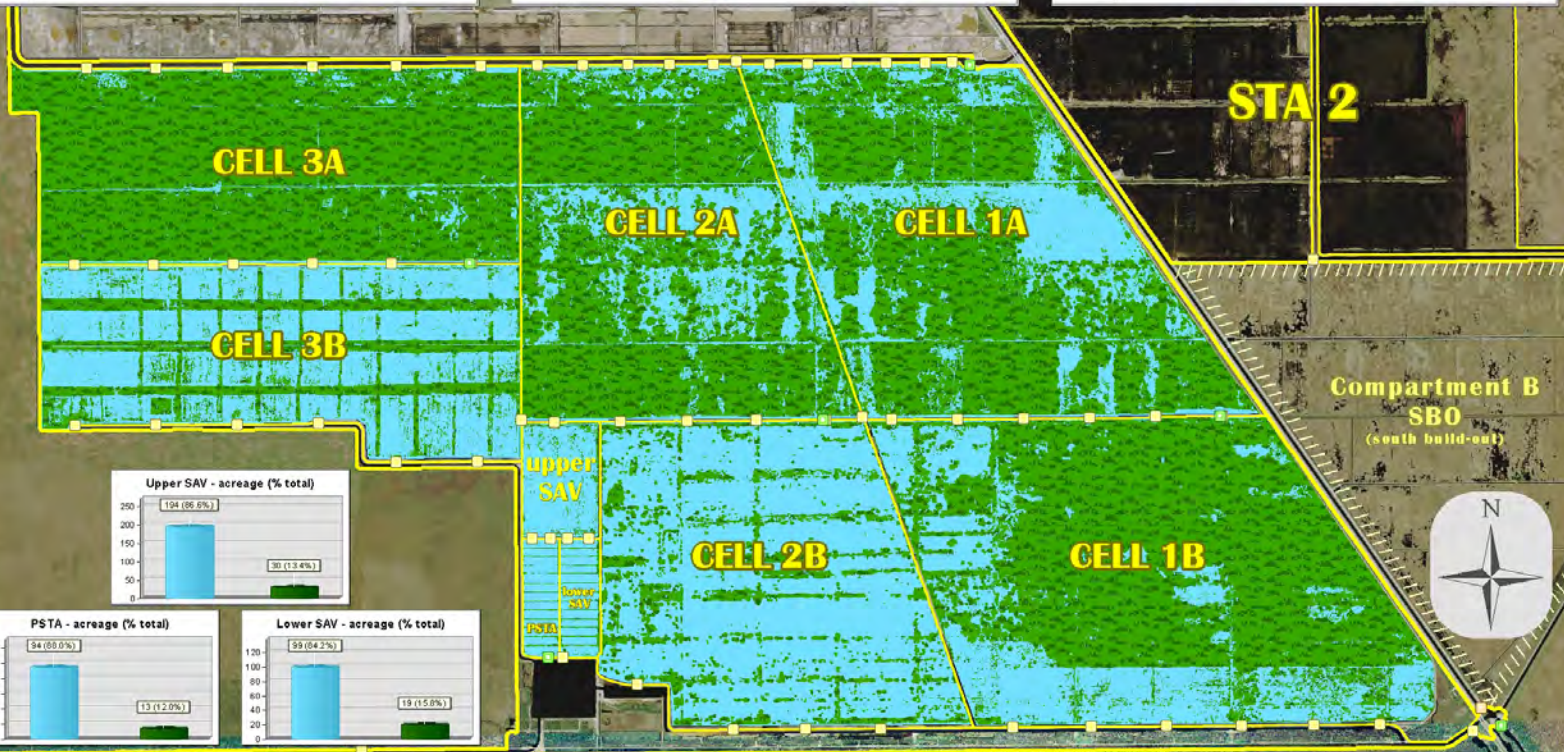
2008 Air Photo Classification Emergent Vegetation Coverage

classification imagery - color infrared 1 foot resolution captured in April 2008

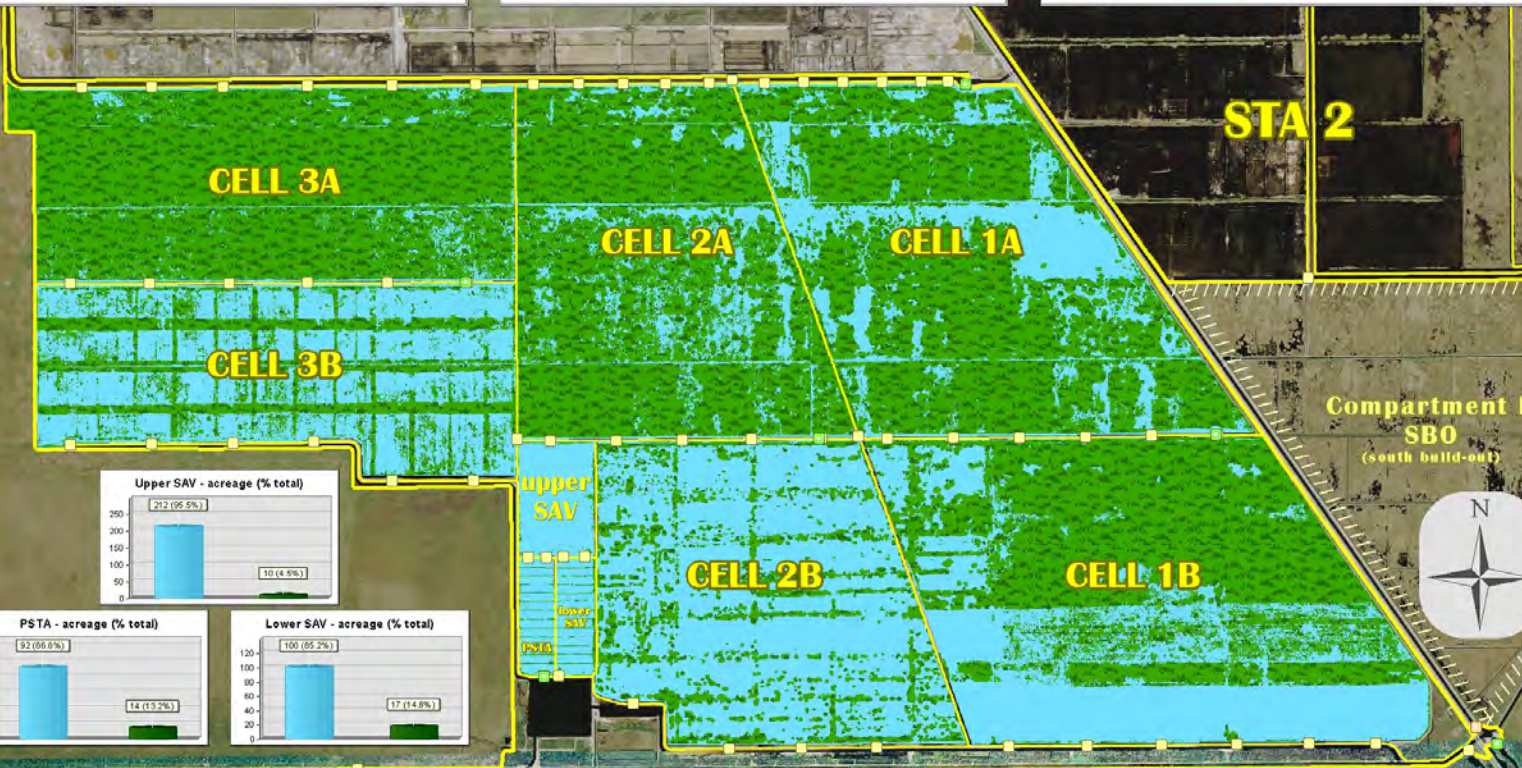
2009 Air Photo Classification Emergent Vegetation Coverage

classification imagery - color infrared 1 foot resolution captured in April 2009
(RASLIB_STA_2009_CIR_1FT_JPG)

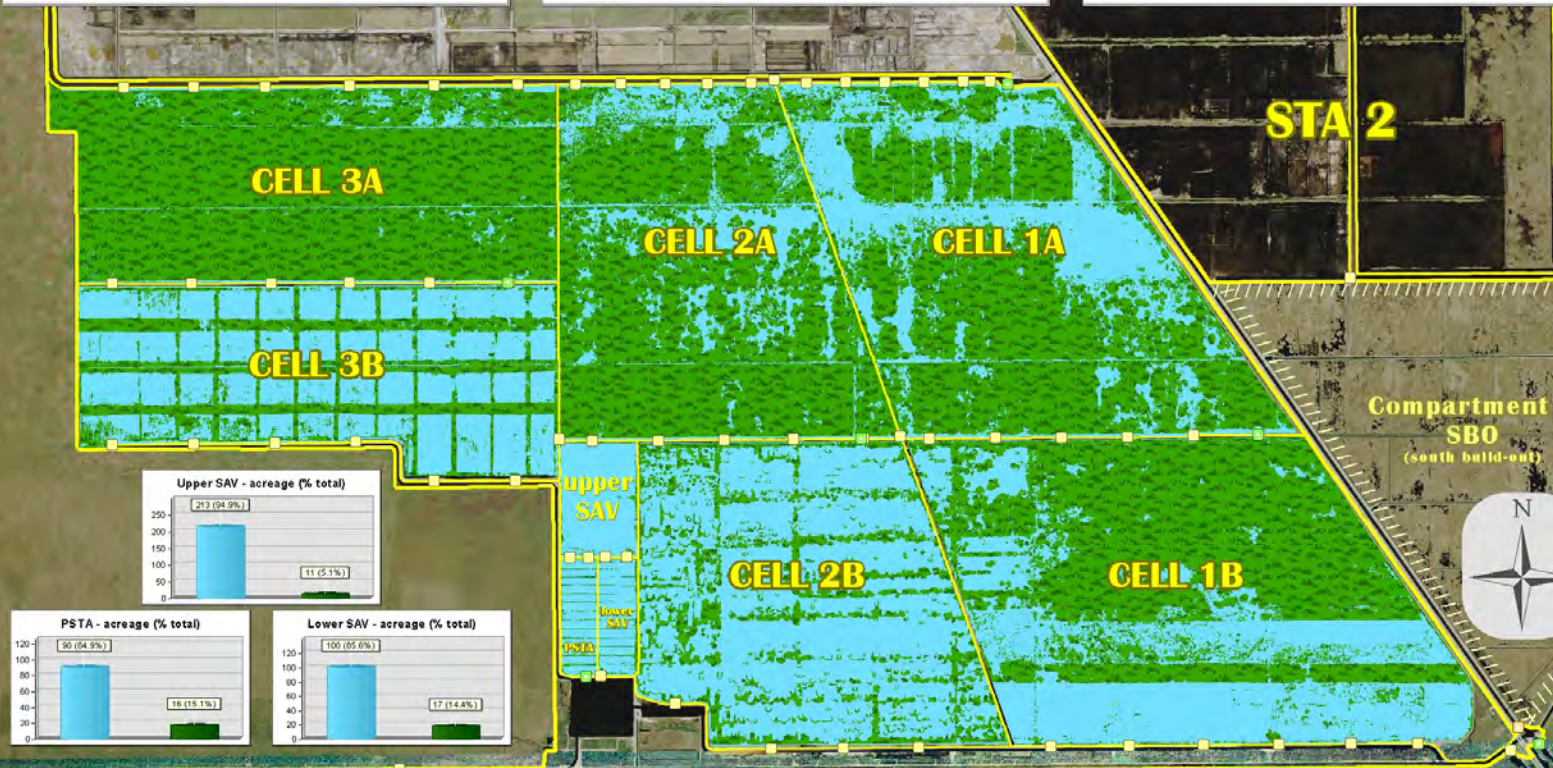
2010 Air Photo Classification Emergent Vegetation Coverage

classification imagery - color infrared 1 foot resolution captured in May 2010
 (\\gisdata1\traster\image_aerial\sta\STA_2010_CIR_1FT_IP2.lyr)

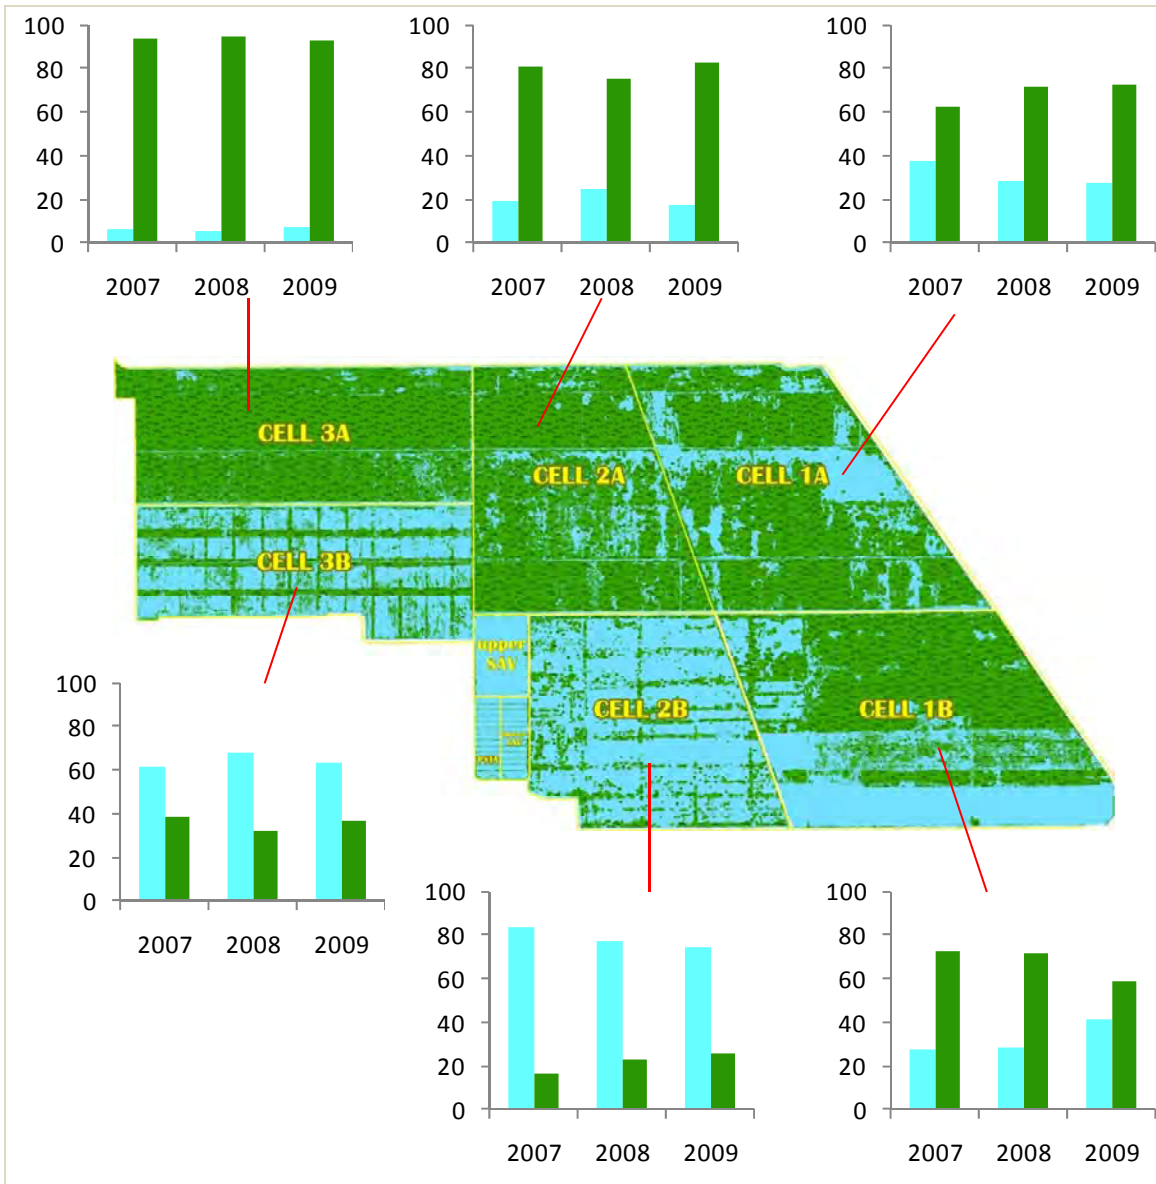
Figure 4. Changes in percent vegetation coverage in Stormwater Treatment Area 3/4 (STA-3/4) (2007–2009) based on aerial images. Blue bars and map area represent SAV-open water and green bars and map area represent EAV. The map shows vegetation coverage from the 2009 aerial images.
Compiled by the SFWMD.

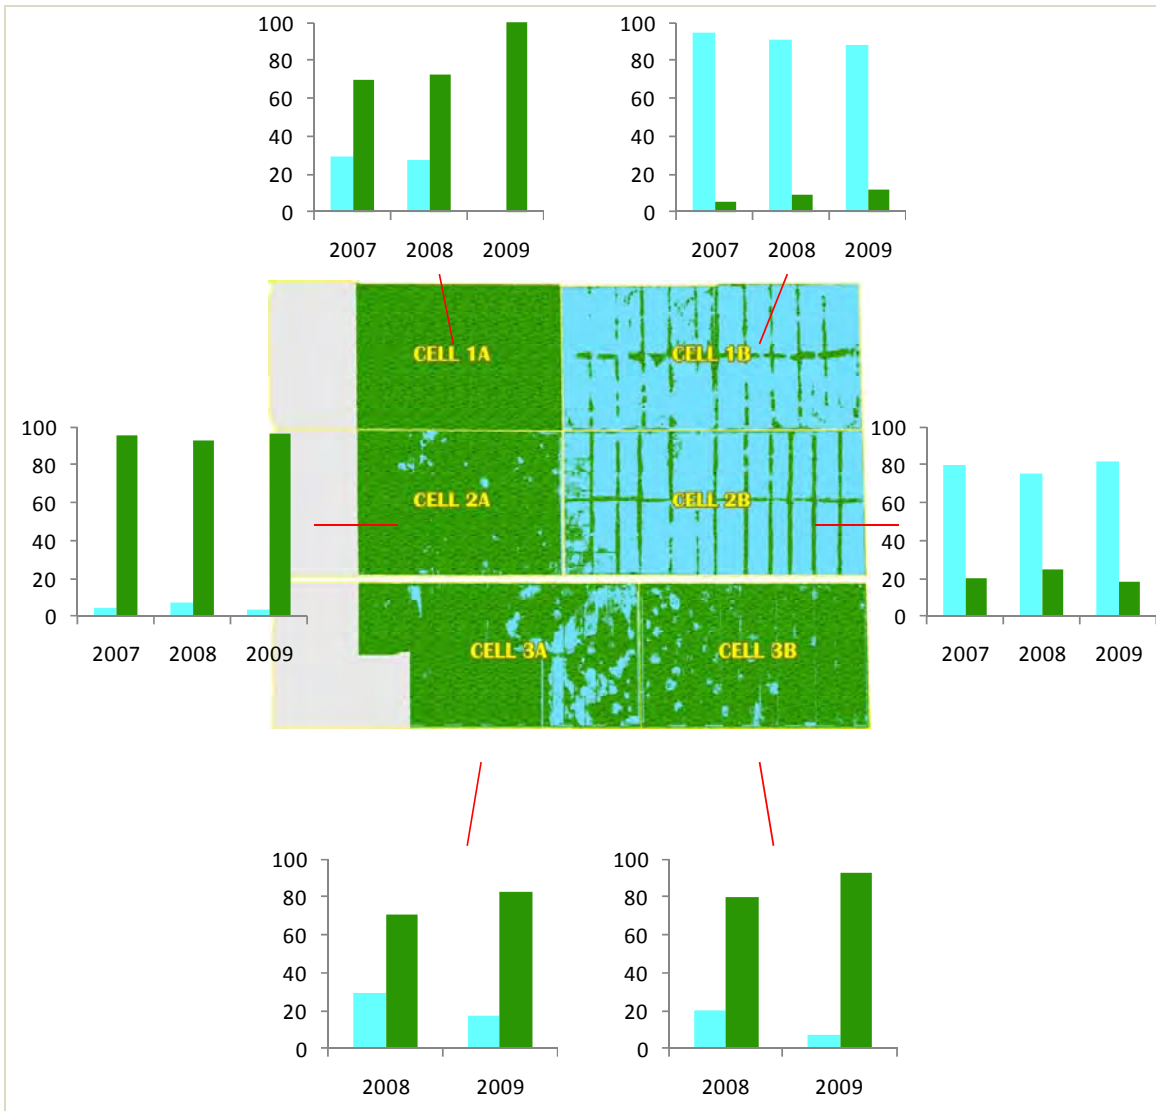
Figure 5. Changes in percent vegetation coverage in Stormwater Treatment Area 5 (STA-5) (2007–2009) based on aerial images. Blue bars and map area represent SAV-open water and green bars and map area represent EAV. The map shows vegetation coverage from the 2009 aerial images. Compiled by the SFWMD.

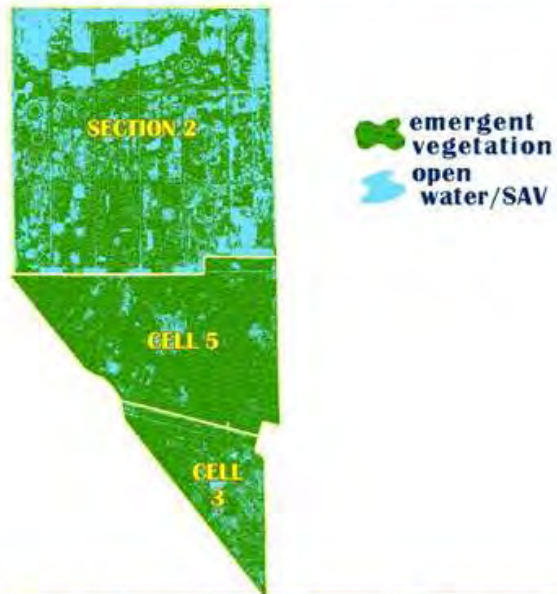
Figure 3. Emergent and submerged aquatic vegetation (EAV and SAV/open water) in STA-5 (upper) and STA-6 (lower) on May 23, 2010.

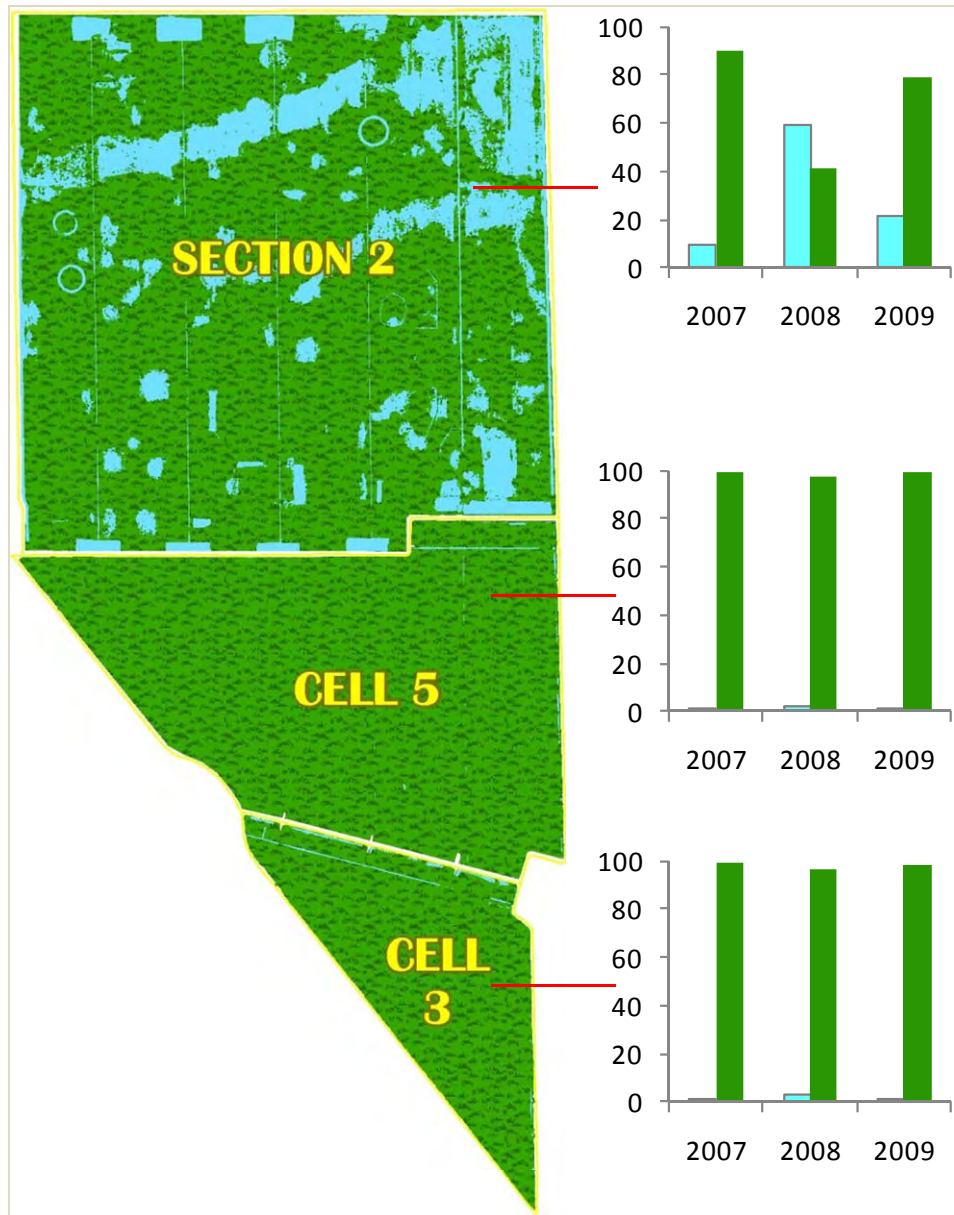
Figure 6. Changes in percent vegetation coverage in Stormwater Treatment Area 6 (STA-6) (2007–2009) based on aerial images. Blue bars and map area represent SAV-open water and green bars and map area represent EAV. The map shows vegetation coverage from the 2009 aerial images.
Compiled by the SFWMD.

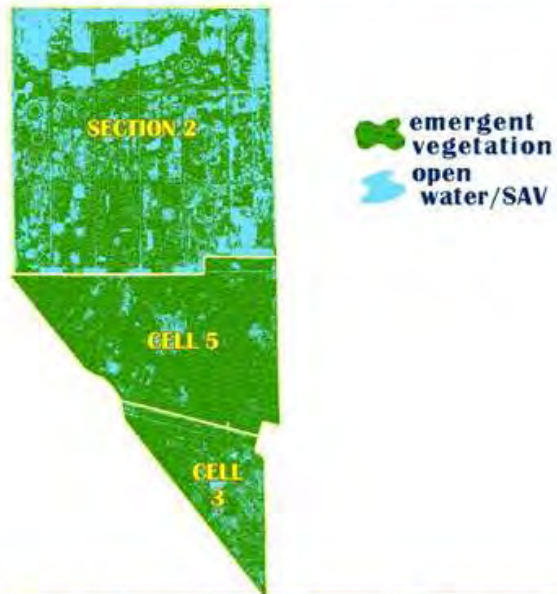
Figure 3. Emergent and submerged aquatic vegetation (EAV and SAV/open water) in STA-5 (upper) and STA-6 (lower) on May 23, 2010.

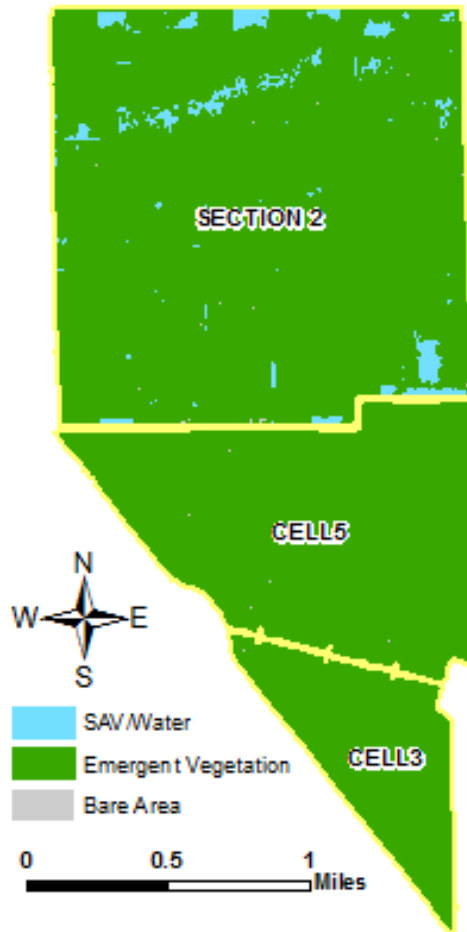
STORMWATER TREATMENT AREA 6

Cell	Coverage Type	Estimated Coverage (acre)	% Coverage	Cell Area (acre)
Section 2	Water/SAV	191.89	14.10	1361.38
	EAV	1168.31	85.82	
	Bare Area	1.17	0.09	
Cell 3	Water/SAV	10.91	4.51	241.88
	EAV	230.76	95.40	
	Bare Area	0.20	0.08	
Cell 5	Water/SAV	7.90	1.27	621.15
	EAV	612.79	98.65	
	Bare Area	0.46	0.07
